Manhole Inspection Summary

Manhole # S31KK1022MH

Location Address: **4401 CHARLES ST**

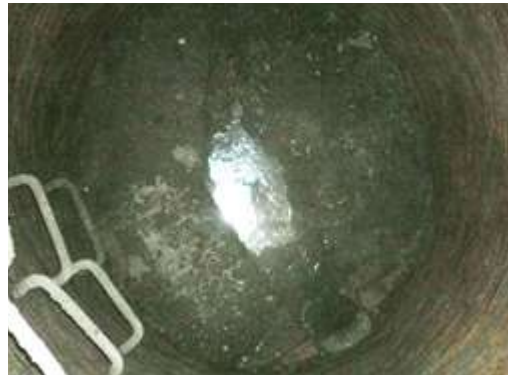
Top View

Evidence of surcharge - Bench debris.
Channel debris.

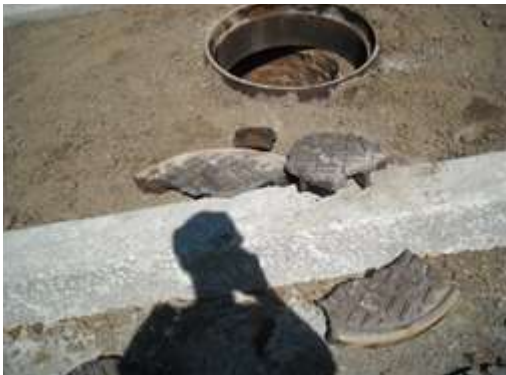
Broke lid

Also replaced the lid.

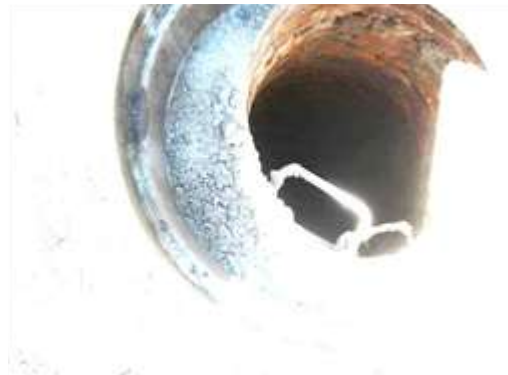
Defect

Frame leaks. Frame offset. Corbel
deterioration and infiltration. Barrel
infiltration.

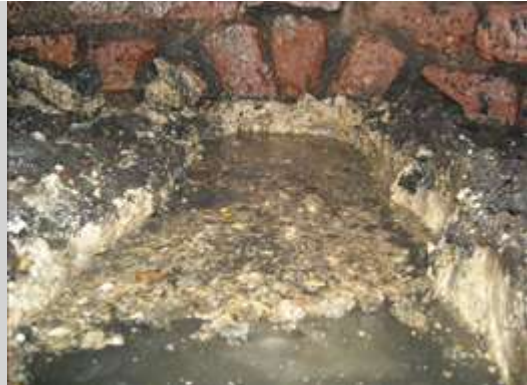
Pipe Out @ 12 O'Clock

Invert Depth: **16.90** (ft.) Flow Characteristics: **Slow**

Deposits: ☐ None ☒ **Mud** ☒ **Sludge** ☒ **Debris** ☒ **Grease**

Silt Depth: **8** (in.) Deposits Extent: **Heavy**

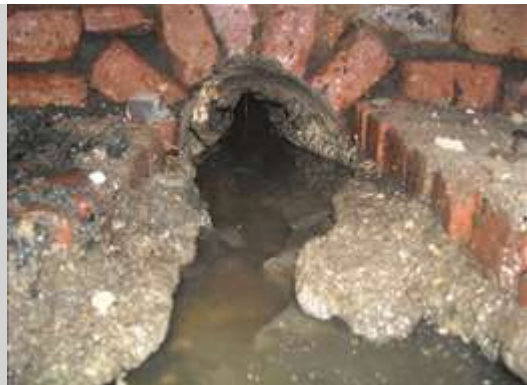
Pipe In @ 4 O'Clock

Invert Depth: **16.63** (ft.) Flow Characteristics: **Slow**

Deposits: ☐ None ☒ **Mud** ☐ Sludge ☒ **Debris** ☒ **Grease**

Silt Depth: **3** (in.) Deposits Extent: **Heavy**
